Lessons from the FIU Bridge Collapse

The Project

- Design and construction of \$12M pedestrian bridge for Florida International University to assist students crossing a busy street and canal
- FDOT funded but administered by FIU
- Design-build

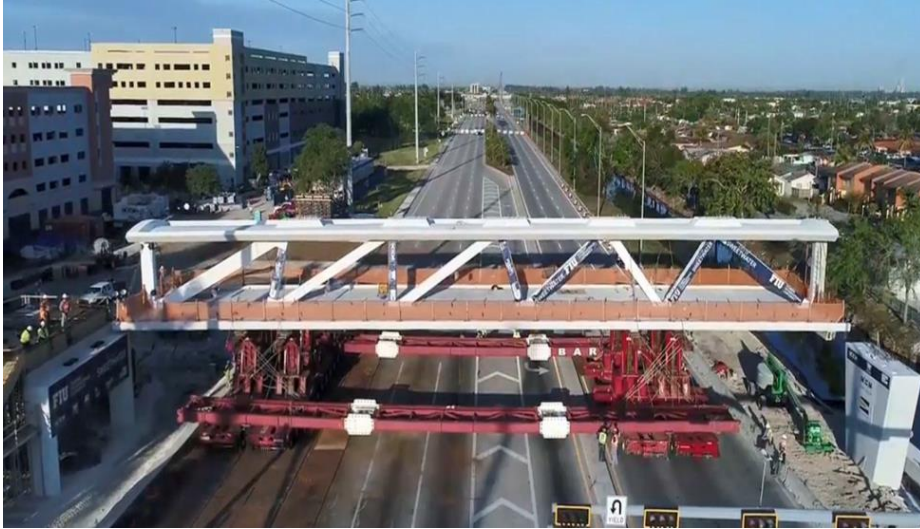
Main Span Construction Method

- “Accelerated Bridge Construction” (ABC) method
- Constructed offsite with post-tensioning completed in casting yard
- Transported to site and placed over south pier and north pylon

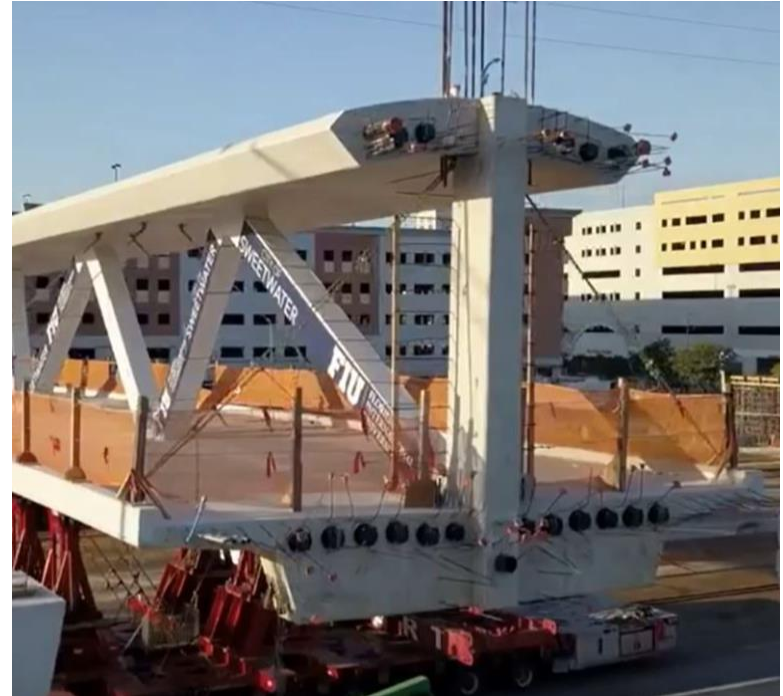
March 10, 2018 – 11:30 a.m.

- Transported to site and placed over south pier and north pylon
- 6 PEs from FIGG present during move, including president of the company
- MCM, BPA, and FIGG examined, no issues reported
- Bracing is removed from truss & supported only by pile/pylon (as designed)

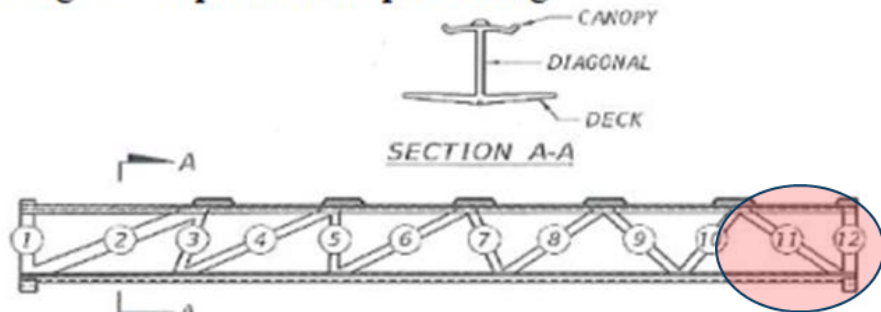
Stage 2 – Superstructure pre-casting

- Per design, certain diagonals (2 and 11) were de-stressed by VSL (post-tension contractor)
- Immediately after de-stress, cracks appear at diagonal 11

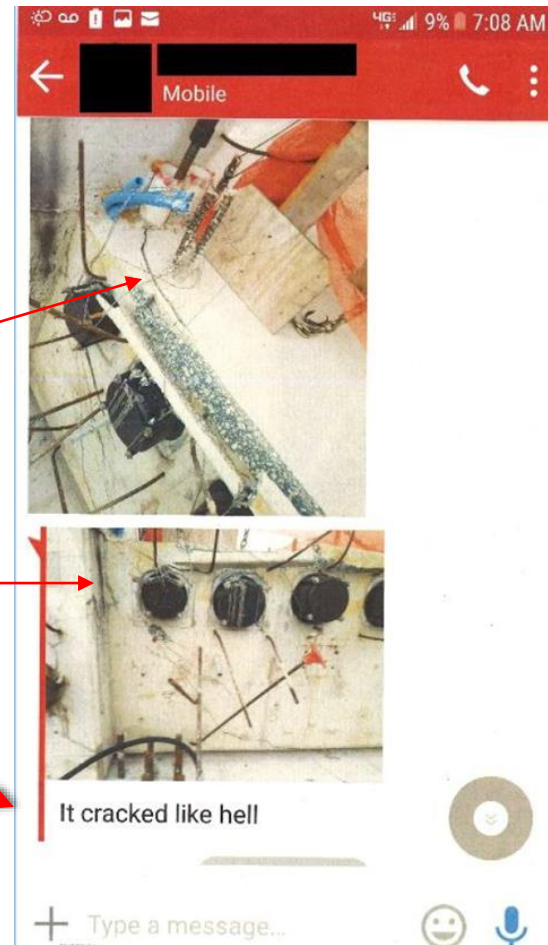
- VSL texts photos of cracking at 11 after de-stressing.
- “It cracked like hell”

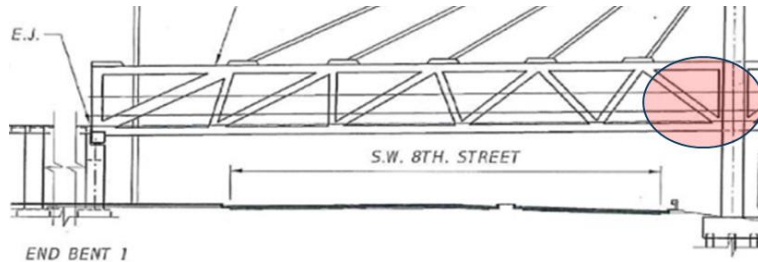
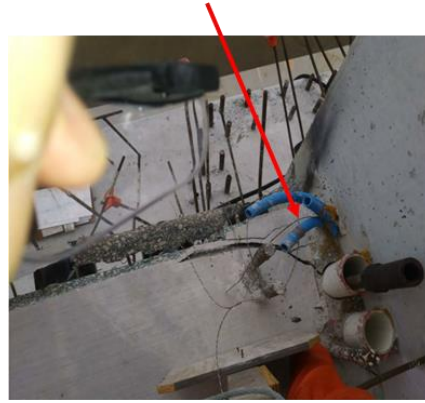
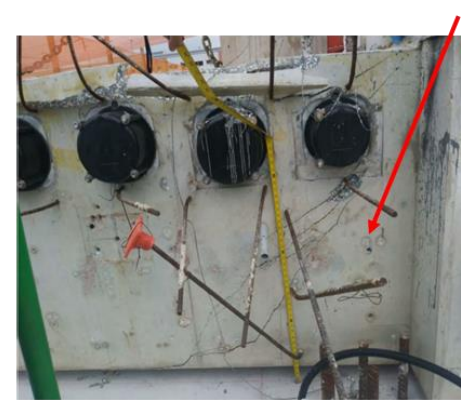
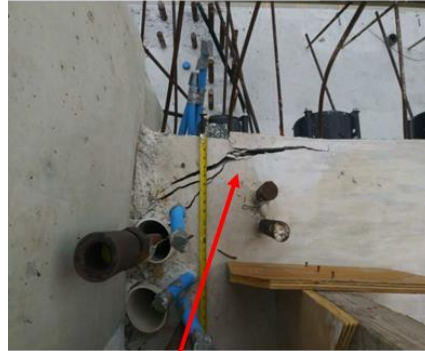
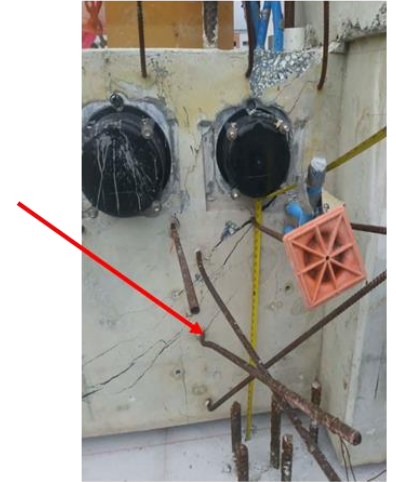
- MCM sends pictures of cracks to FIGG asking them to review and comment “as quickly as possible”

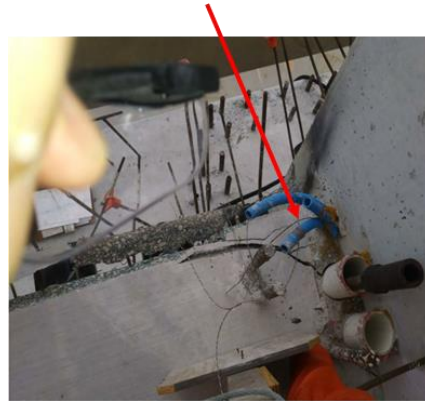
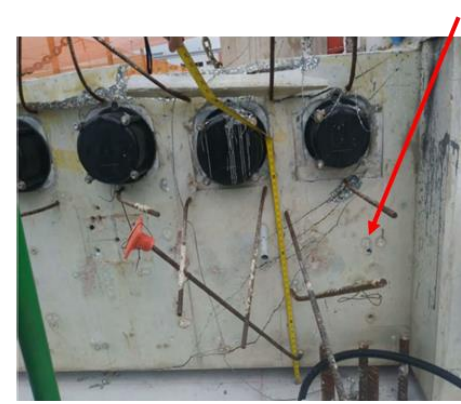
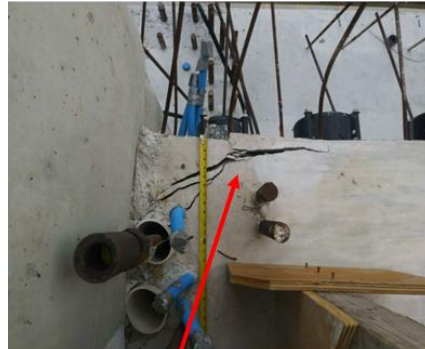
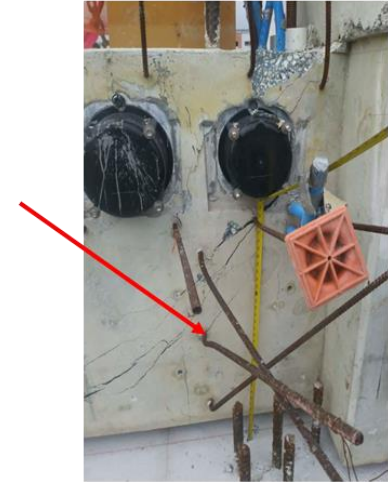
- FIGG opens e-mail 8:30
- 9:45 FIGG instructs by e-mail to put plastic shims in “right away” but no jacking is required
- “We do not see this as a safety issue”

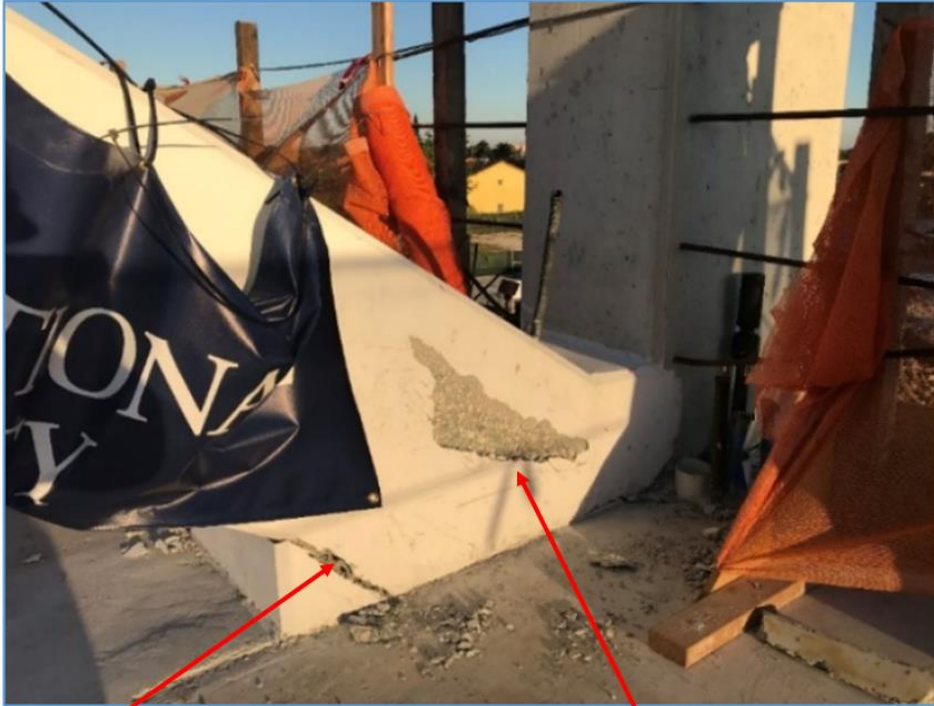
March 13, 2018

- FIGG leaves message for FDOT about cracking but says “we don’t see that there’s any [safety] issue there, so we’re not concerned about it from that perspective”
- 5:18 FIGG e-mails MCM “we have evaluated further and confirmed this is not a safety issue”
- FIGG recommends to restress PT rods at member 11 but VSL crew couldn’t be back on site until March 15

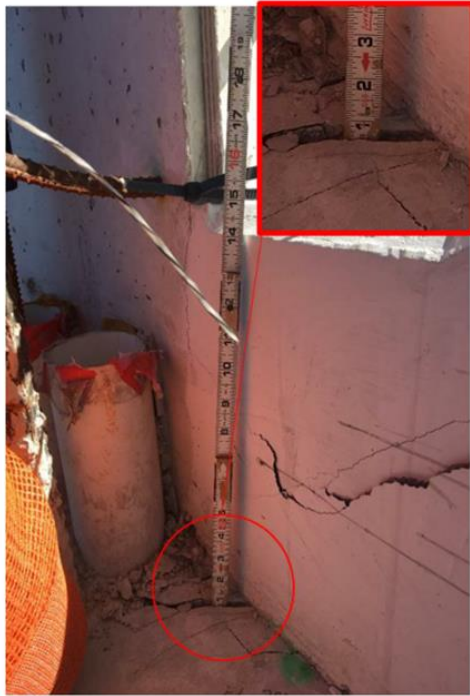
West side

March 14, 2018 – West and East Sides

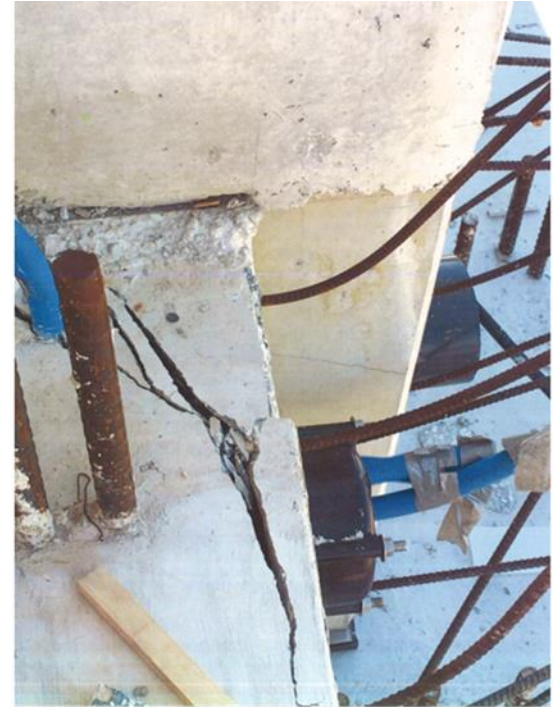
March 14, 2018

- MCM sees cracks growing
- Calls meeting with FIGG and others for morning of March 15 to discuss FIGG's findings on cracks
- FIGG analyzes, works on presentation for meeting
- VSL told to mobilize for re-tensioning on March 15

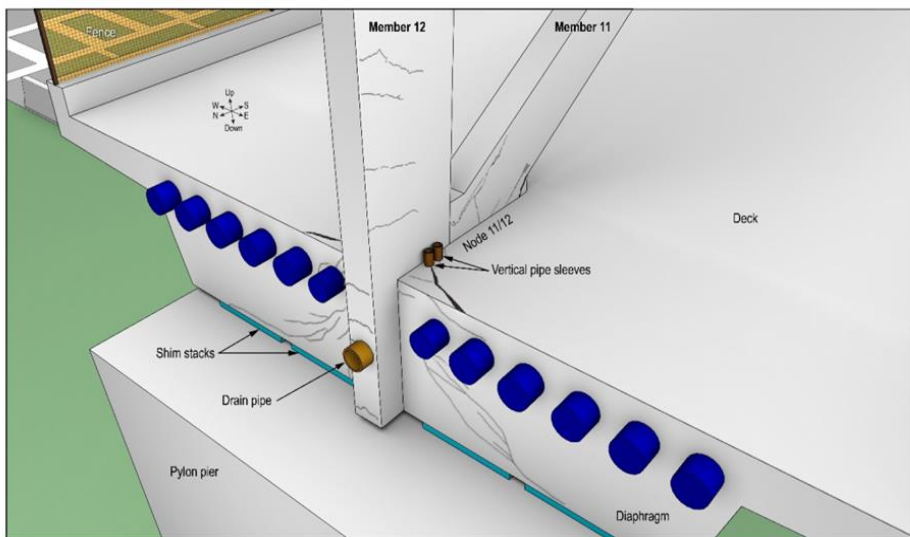
Figure 33. South and west view of extent of cracking at member 11/12 nodal region, deck, and diaphragm, indicating structural distress.

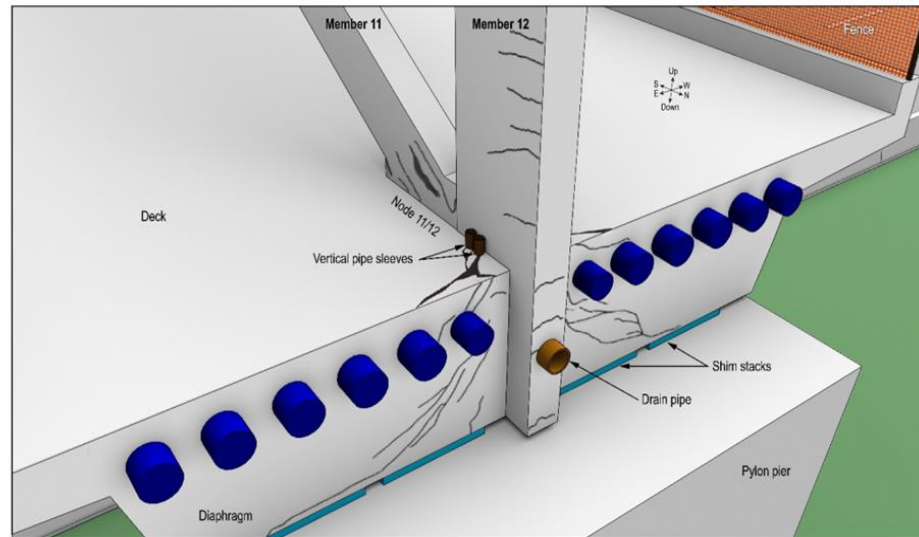
Figure 34. South and east view of extent of cracking at member 11/12 nodal region, deck, and diaphragm, indicating structural distress.

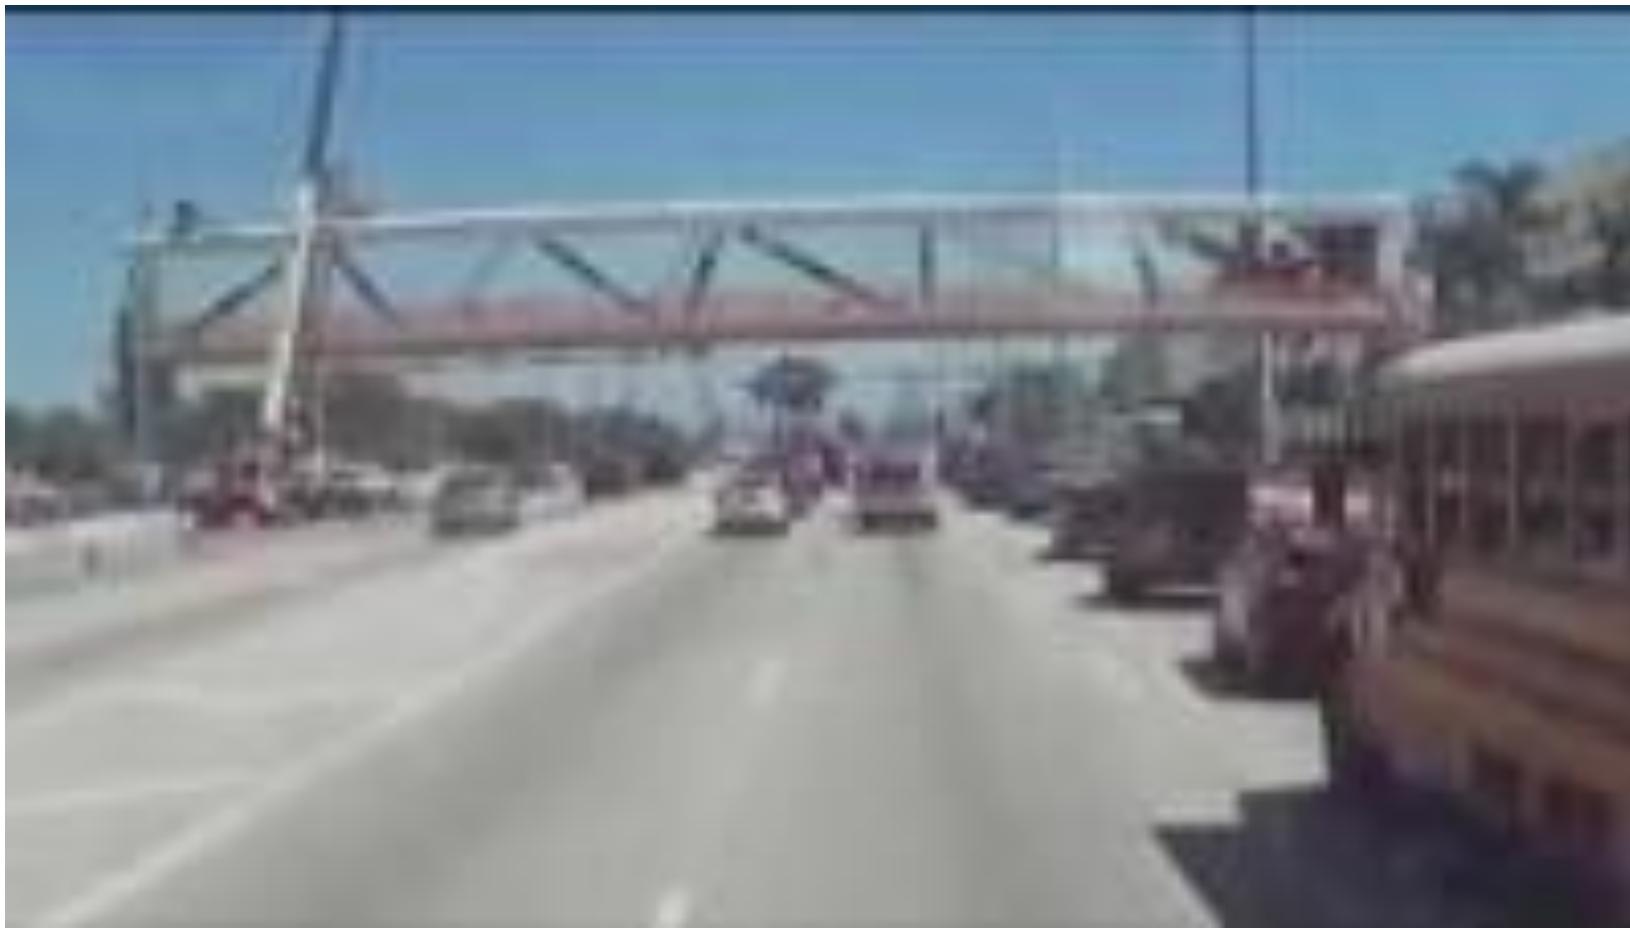
March 15, 2018
1:46 p.m.

- Span “experienced a blow-out of concrete [at] diagonal 11 and column 12.”
- Span fell 18 feet to the ground.
