Do What You Have to Do. I Trust You!

**GEOPROFESSIONAL
BUSINESS
ASSOCIATION**

**CASE
HISTORY** **93**

PROJECT MANAGEMENT

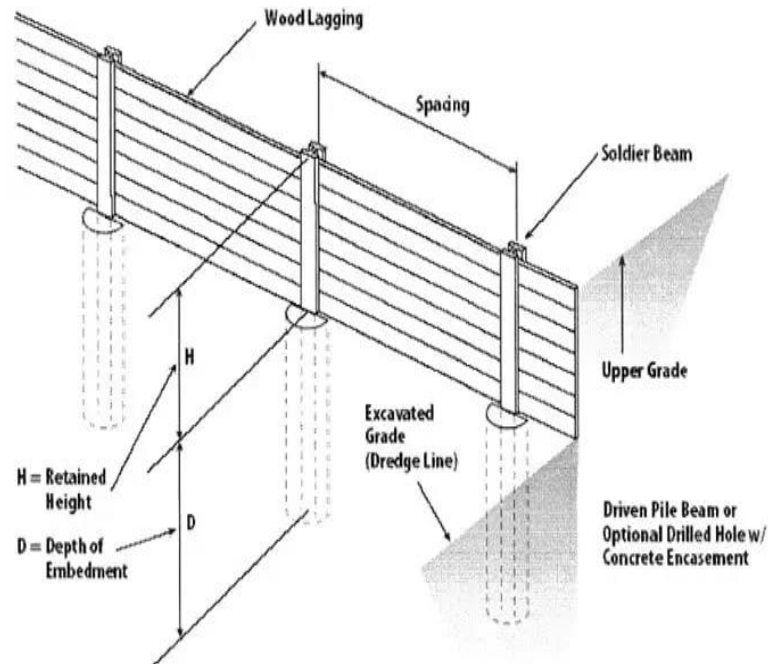
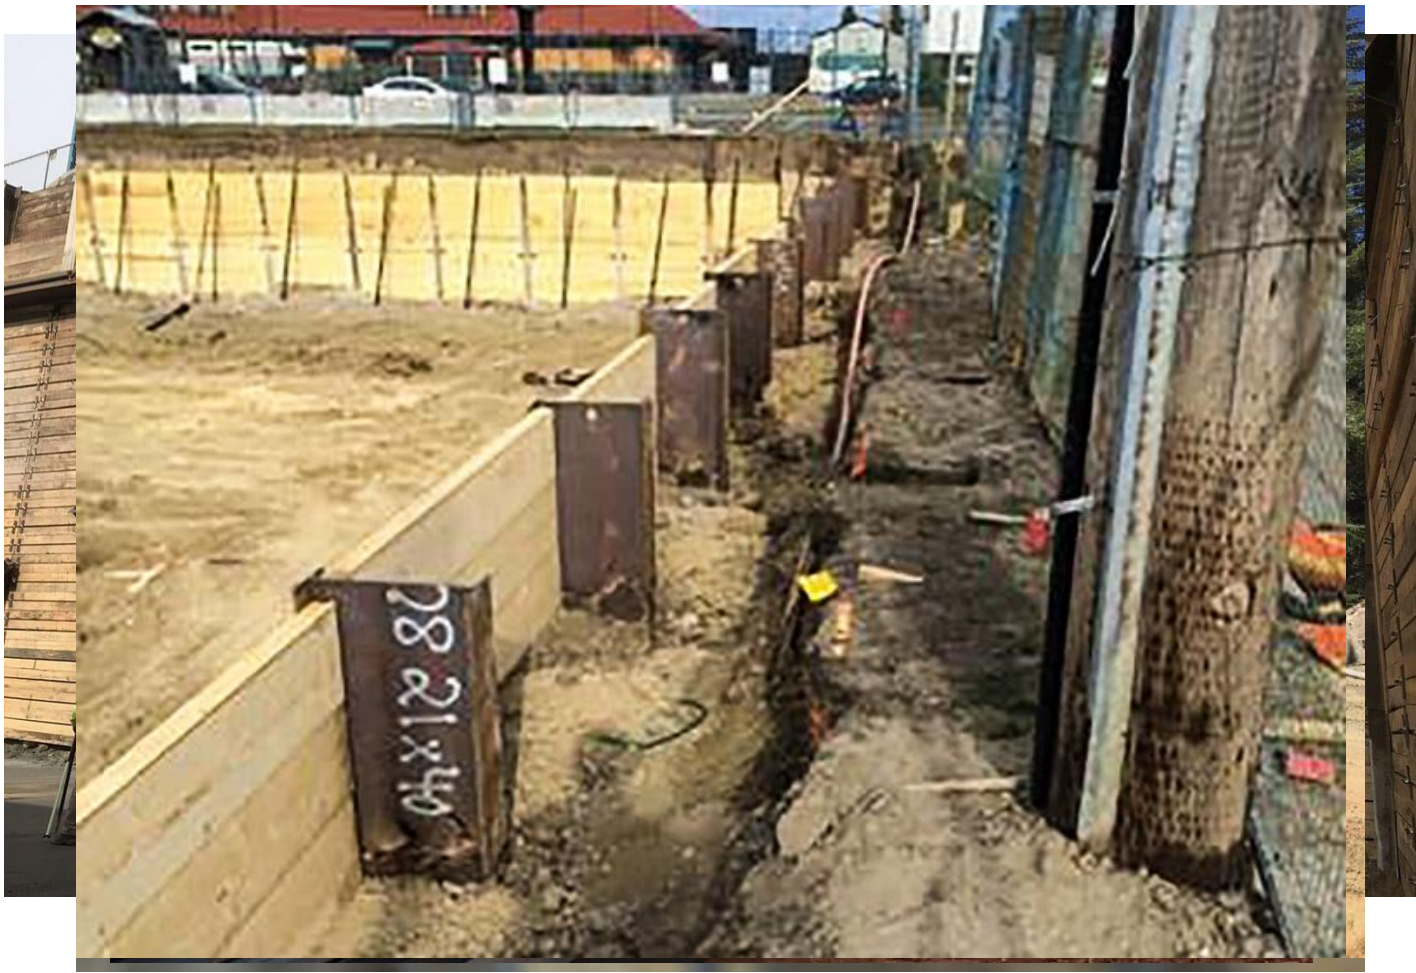
SHORING SYSTEM FOR SUBSURFACE

- Steel H-sections placed in 24-in diameter drilled hole
- Tips of piles embedded into underlying very dense gravel
- Backfilled with structural concrete to excavation level
- From excavation level to ground surface, backfilled with “lean-mix” concrete

Construction began with installation of soldier piles for the perimeter shoring system, designed to consist of steel H-sections embedded in a 24-inch-diameter drilled hole and backfilled with structural concrete to the excavation level. From the excavation sub-grade to the ground surface, the remainder of this hole was to be backfilled with a "lean-mix concrete" that allowed it to be easily chipped away during lagging and anchor installation. Curiously, the shoring designer failed to delineate structural-concrete and lean-mix concrete requirements in the construction documents, and—because the lean-mix concrete was temporary—the city building department did not require it to be tested.

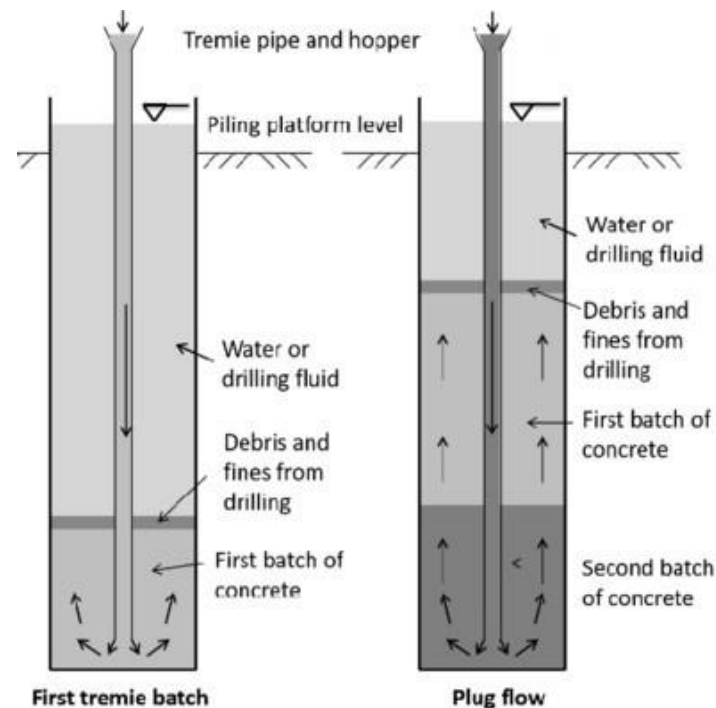
CONSTRUCTION BEGINS

- Shoring contractor contacted Member Firm CEO for “permission” to free fall concrete while encasing H-piles rather than using a tremie
- CEO approved change to method

The shoring contractor asked the Member Firm's CEO/project manager to give the contractor "permission" to "lean-tilt" the lean-mix concrete instead of using tremie methods. Without asking for clarification, the CEO said that free-falling would be acceptable as long as the contractor directed the "lean-mix" into the H-section web, to reduce the risk of soil being incoated from the drilled excavation. Installation of the soldier piles took about 5 months. The contractor tipped the piles in the very dense-gravel formation underlying the project site.

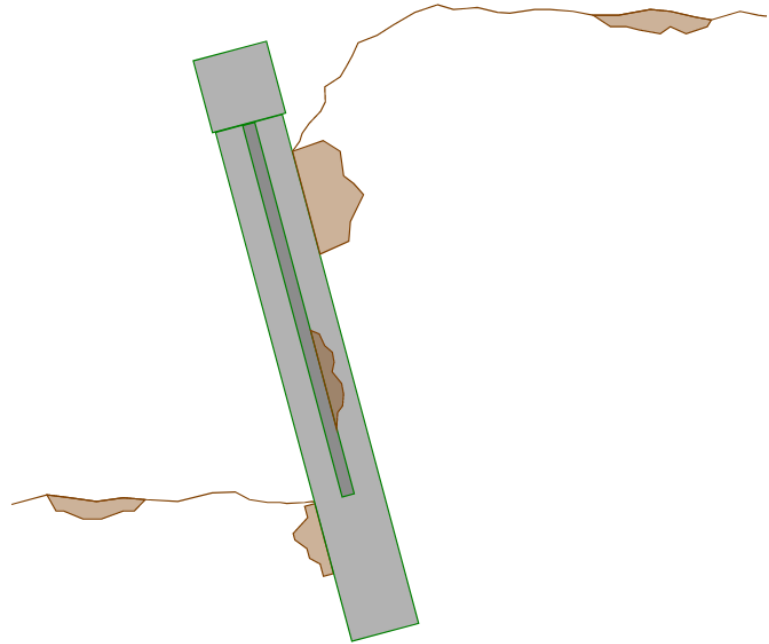
PROBLEMS BEGIN

- Three soldier piles settled and rotated
- GC opted to push soil stockpile up against failed portion of wall, and installed additional anchors and micropiles to prevent collapse

Problems and Outcomes
As the excavation was nearing completion, three soldier piles in the northeast corner of the excavation plunged downward between 12 and 18 inches and rotated about

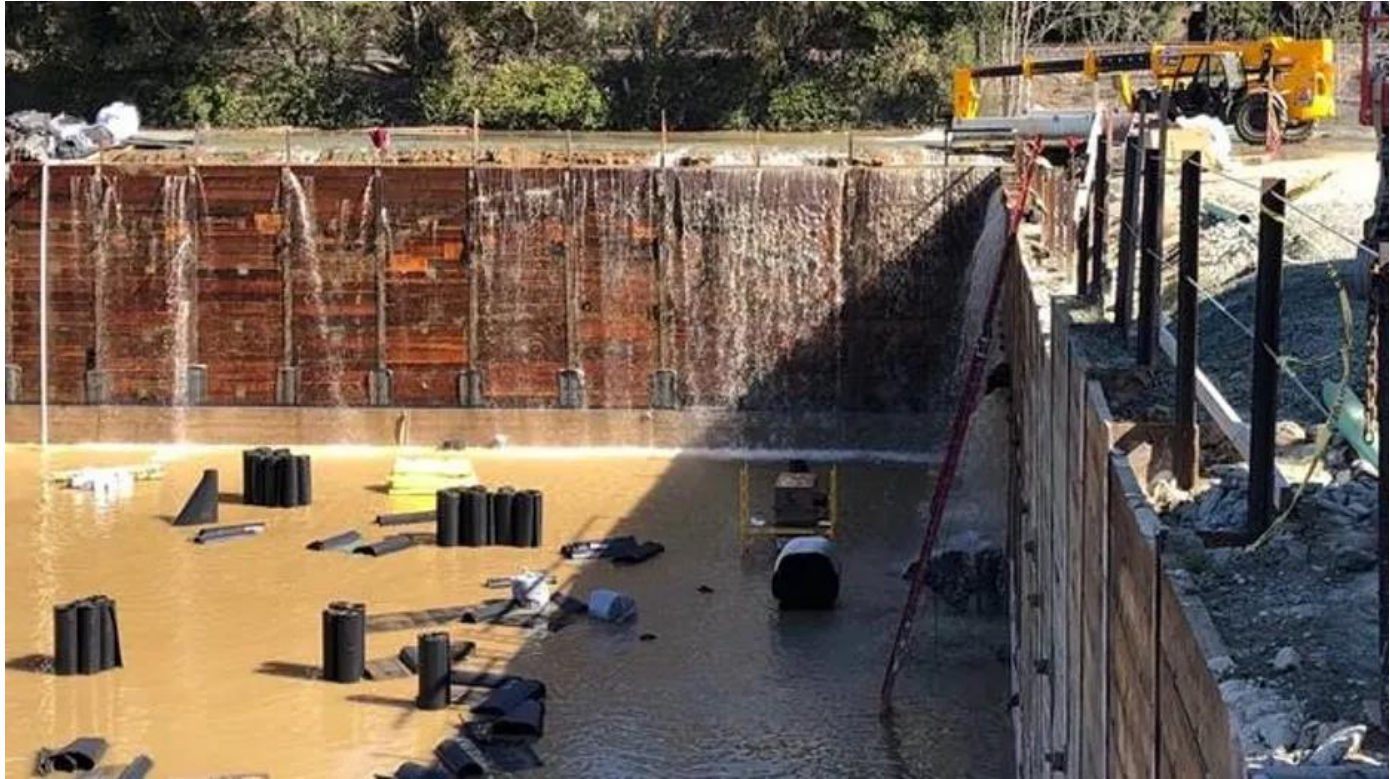
WORST FEARS COME TRUE

- Five days later!
 - Entire north wall of shoring (700 ft) plunged downward and rotated
 - Earth movement led to rupture of 8-inch, high-pressure water line which blew out 30-feet of lagging and flooded excavation
- Damage to adjacent streets, sidewalks, and historic buildings
- \$4.5-million*, which includes construction delays, repairs to adjacent improvements, shoring repairs, and consulting costs

- Failure occurred when H-piles plunged through 25-psi lean-mix at tips
 - There was no failure where the strength reflected 800+ psi
 - Concrete supplier indicated shoring contractor directed them to remove fly ash and double water:cement ratio
 - Contractor installed failed piles on the days when the supplier delivered weaker mix
- Shoring contractor indicated that since project was design-build, he didn't need a submittal for change to mix
 - Since piles are temporary, City did not require testing

- Over the following weeks, shoring contractor installed additional tie-back anchors and micropiles under all failed soldier piles
- Constructor-in-charge absorbed cost of delays and redesign of walls
- Client's project insurance covered cost to repair damaged buildings and infrastructure
- Client's CEO insisted that shoring contractor reimburse GBA Member Firm for their costs of forensic investigation
