West Fork Upper Battle Creek Diversion

Jason H. Thom, P.E.

Project Overview

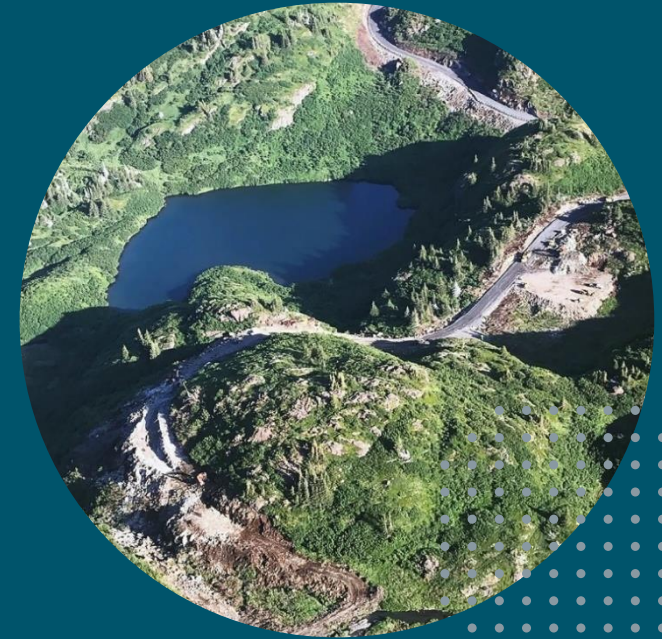
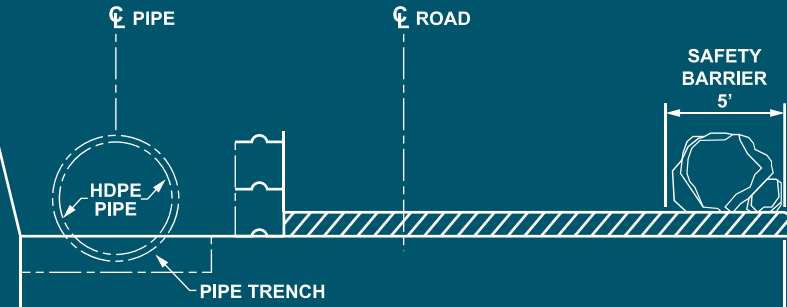
- 3 miles of new roads
- 2 miles 63" HDPE pipe
- 1,000 CY diversion cast-in-place concrete
- Large (96") Fiber Reinforced Pipe (FRP)
- 250,000 CY of rock excavation (blasting)
- 150,000 CY embankment and sub-base
- 5,000 Ecoblocks (pipe containment blocks)

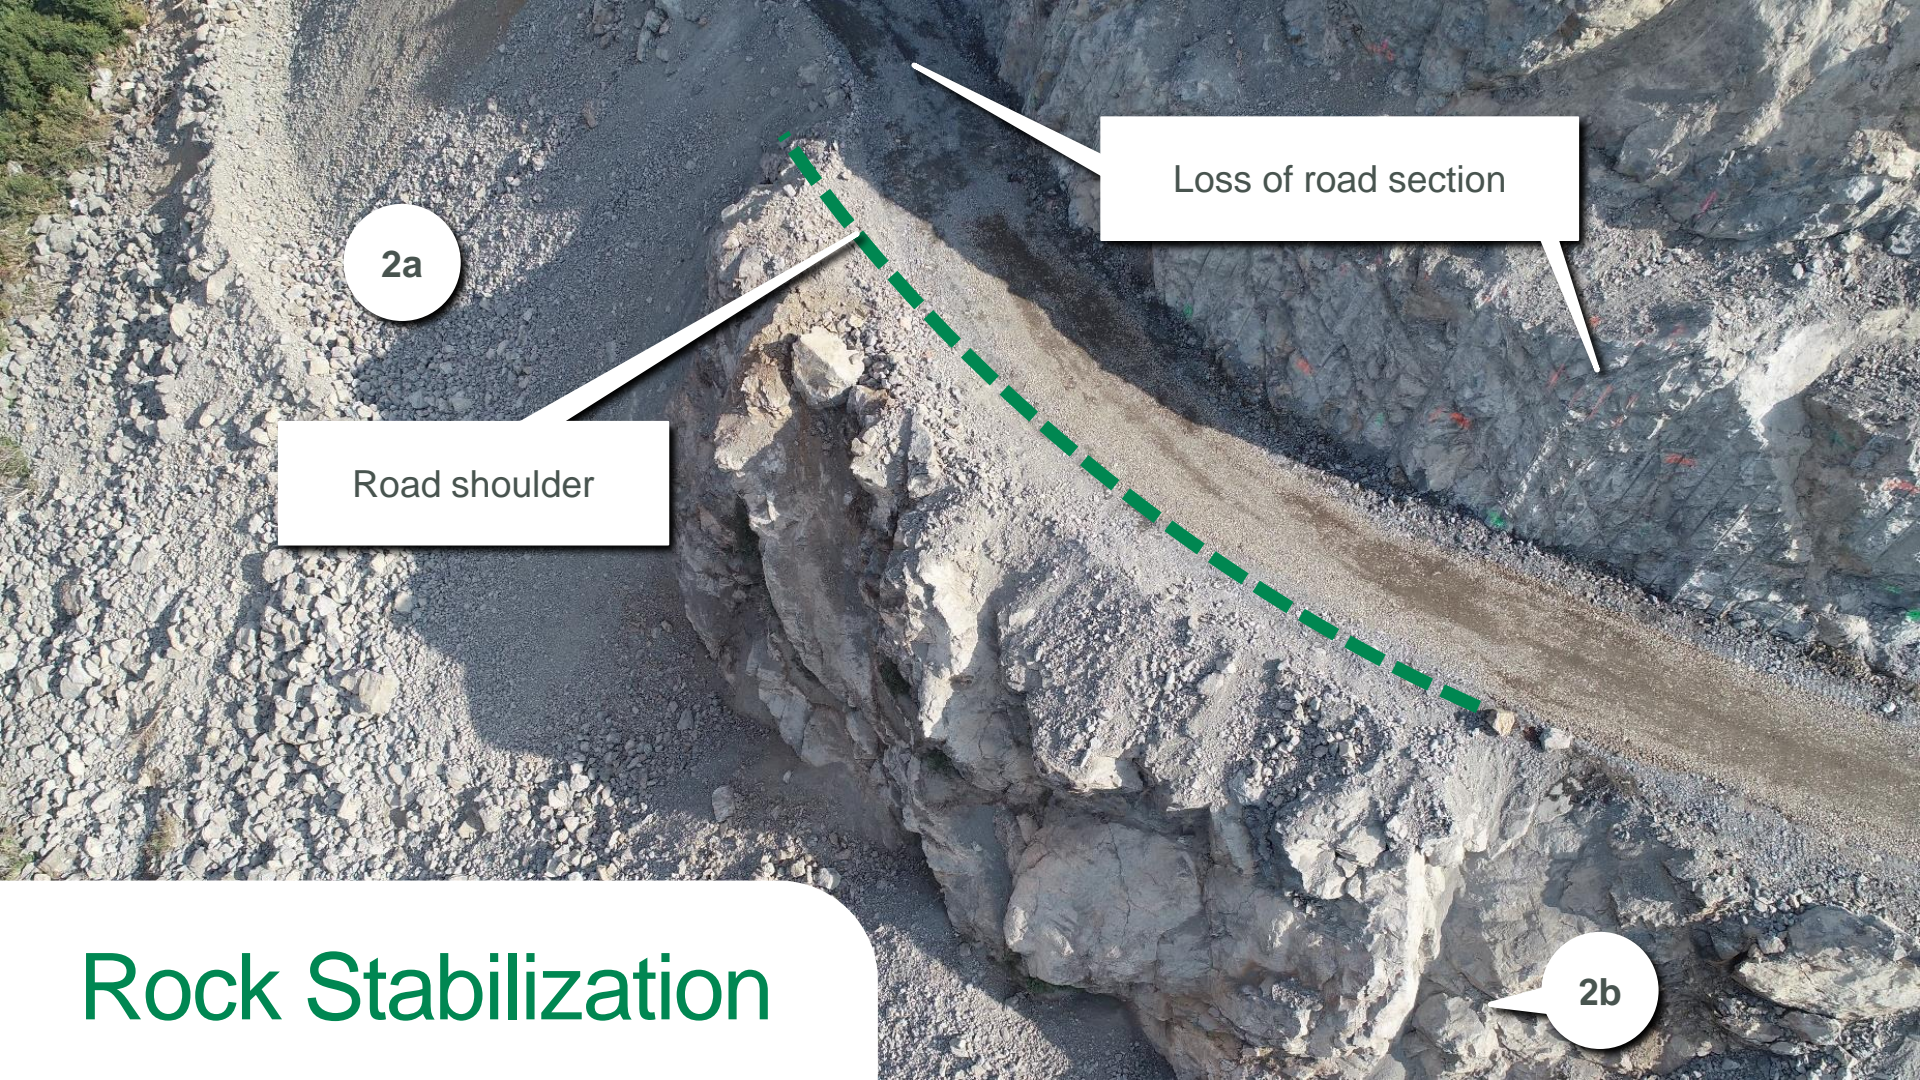
2a

Road shoulder

Loss of road section

2b

Rock Stabilization

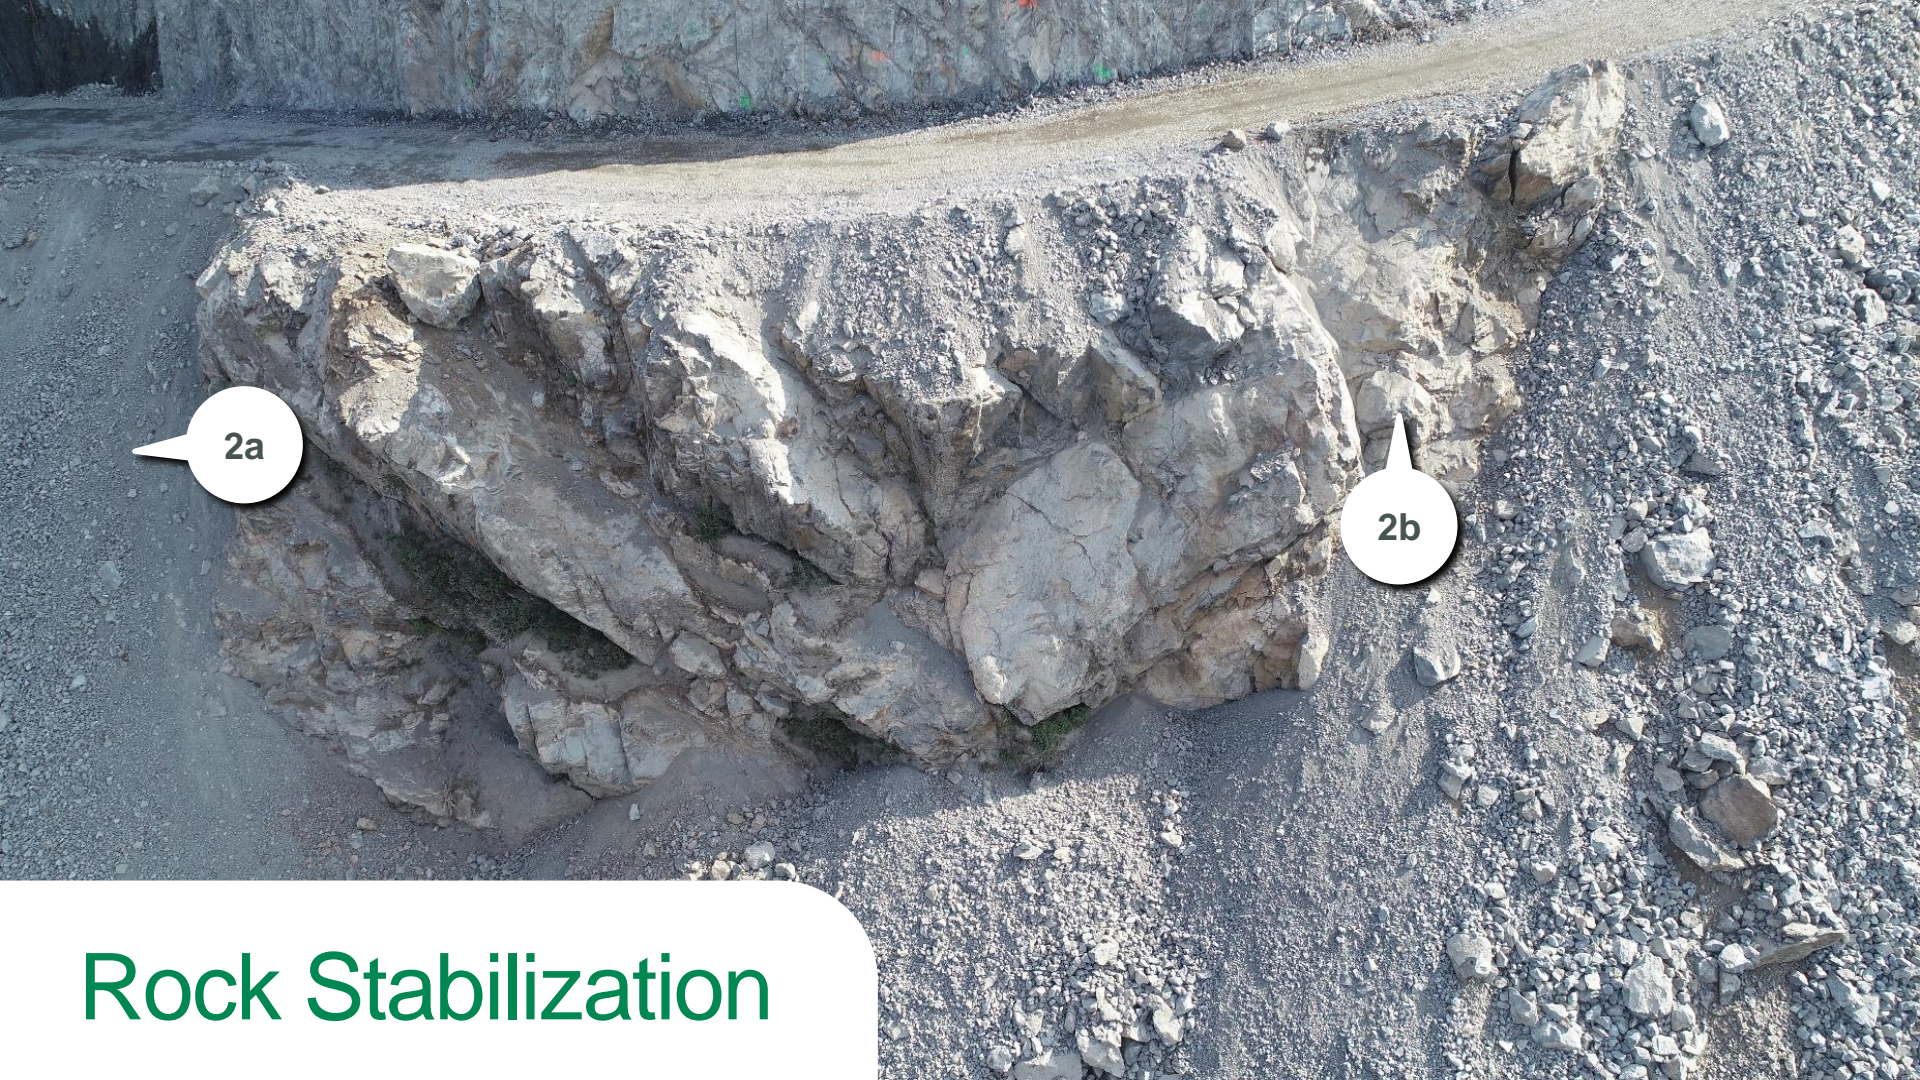
Rock Stabilization

2a

2b

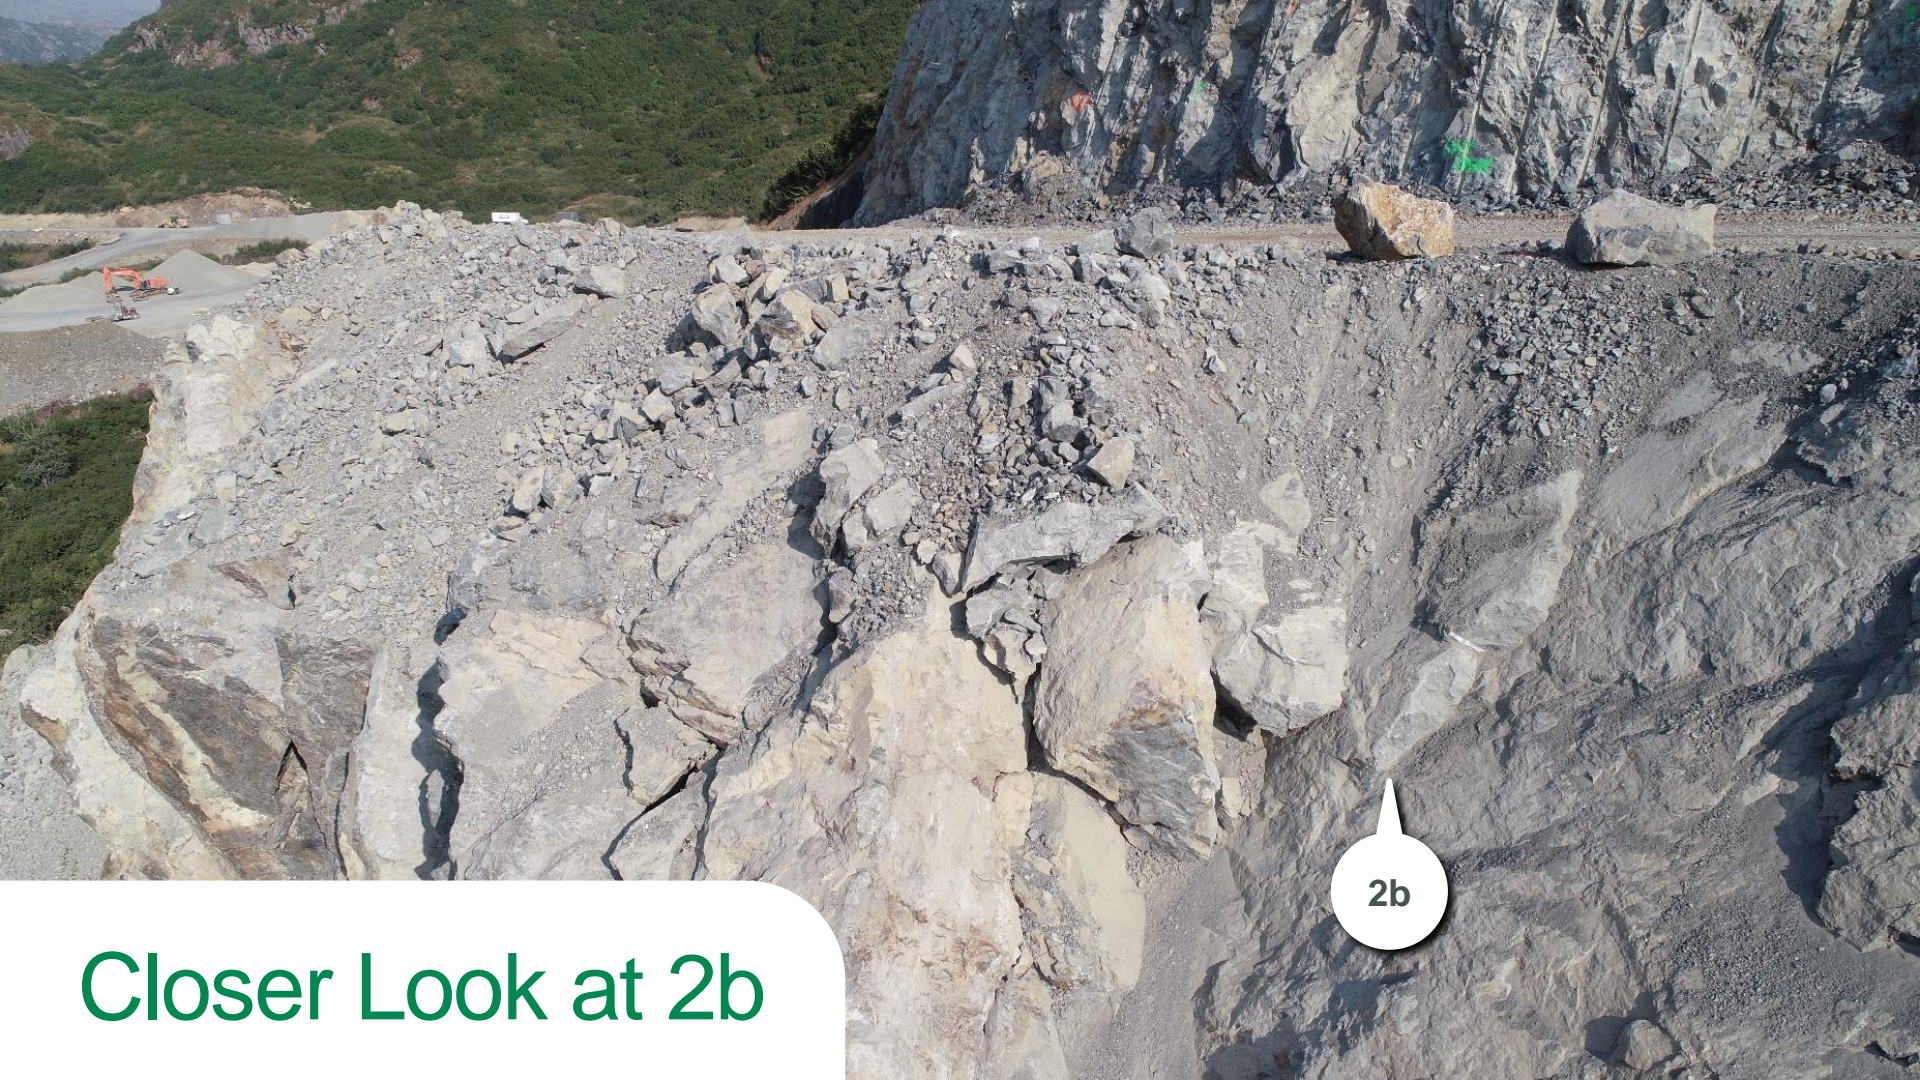
Closer Look at 2b

2b

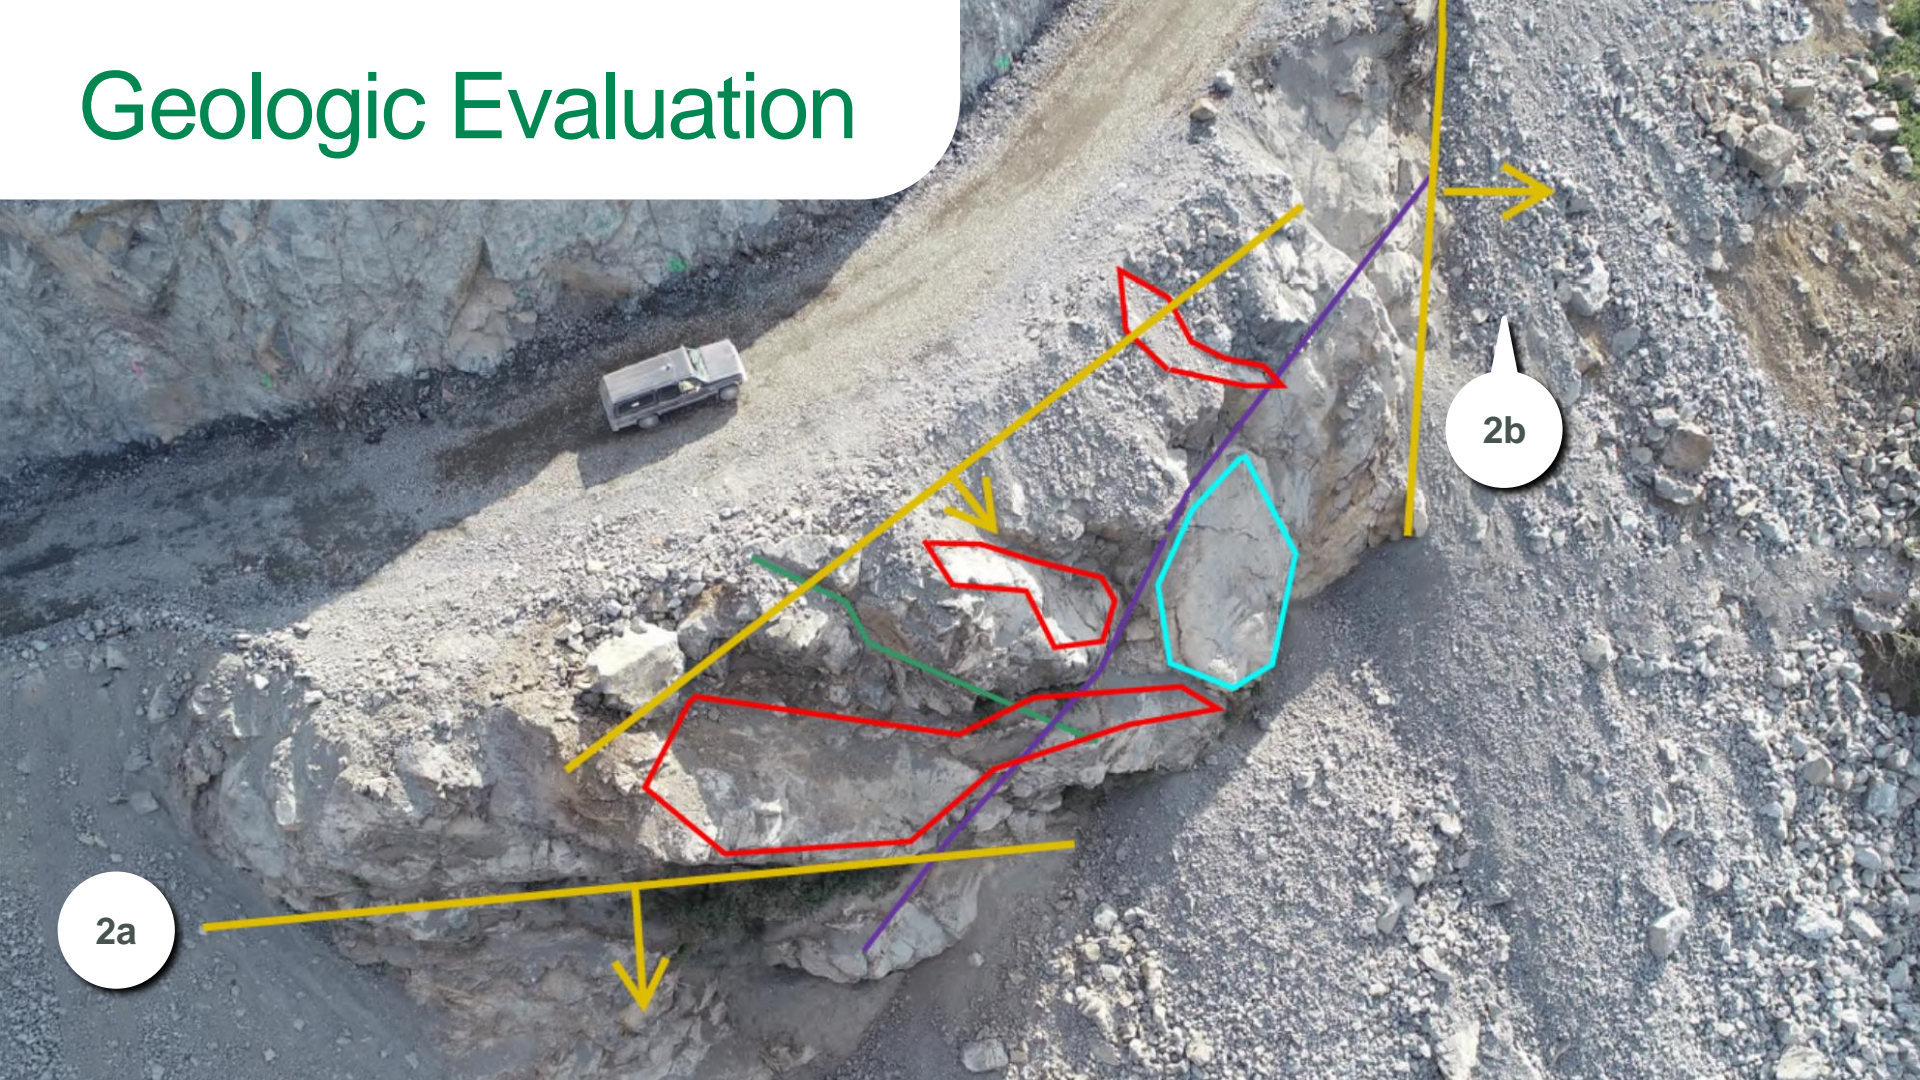
Geologic Evaluation

Joint Set 4

The image shows a rock face with three distinct joint sets highlighted by colored lines. Joint Set 4 is a horizontal line at the top. Joint Set 1 is a large red polygon covering the central and lower-left portions of the face. Joint Set 2 is a cyan polygon in the lower-right corner. A green polygon is also present in the center-right area. A yellow line runs horizontally across the top of the rock face.

Joint Set 1

Joint Set 2

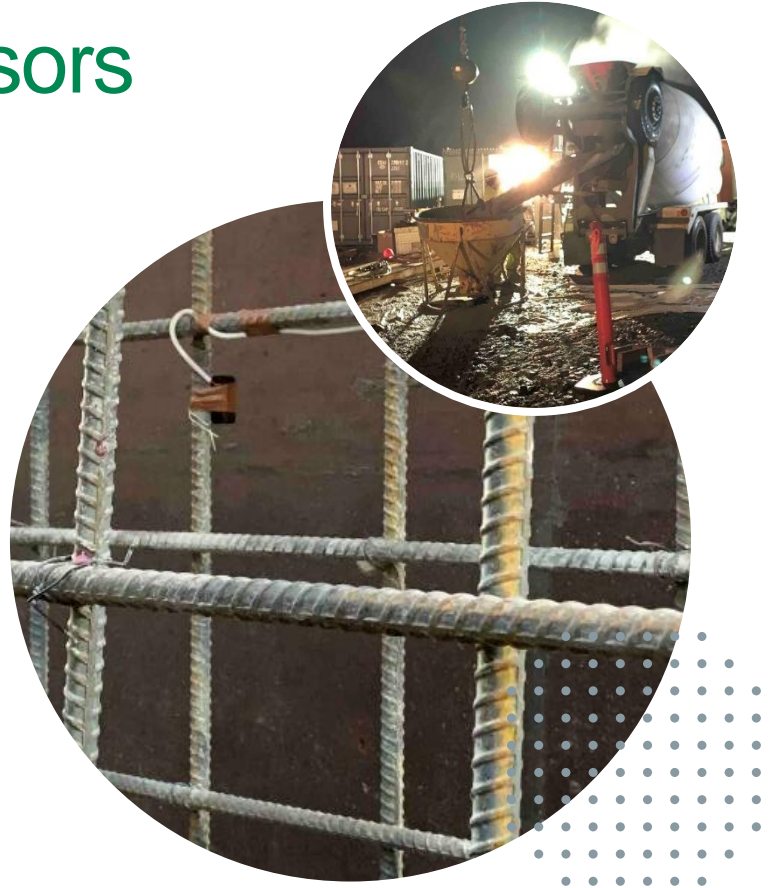
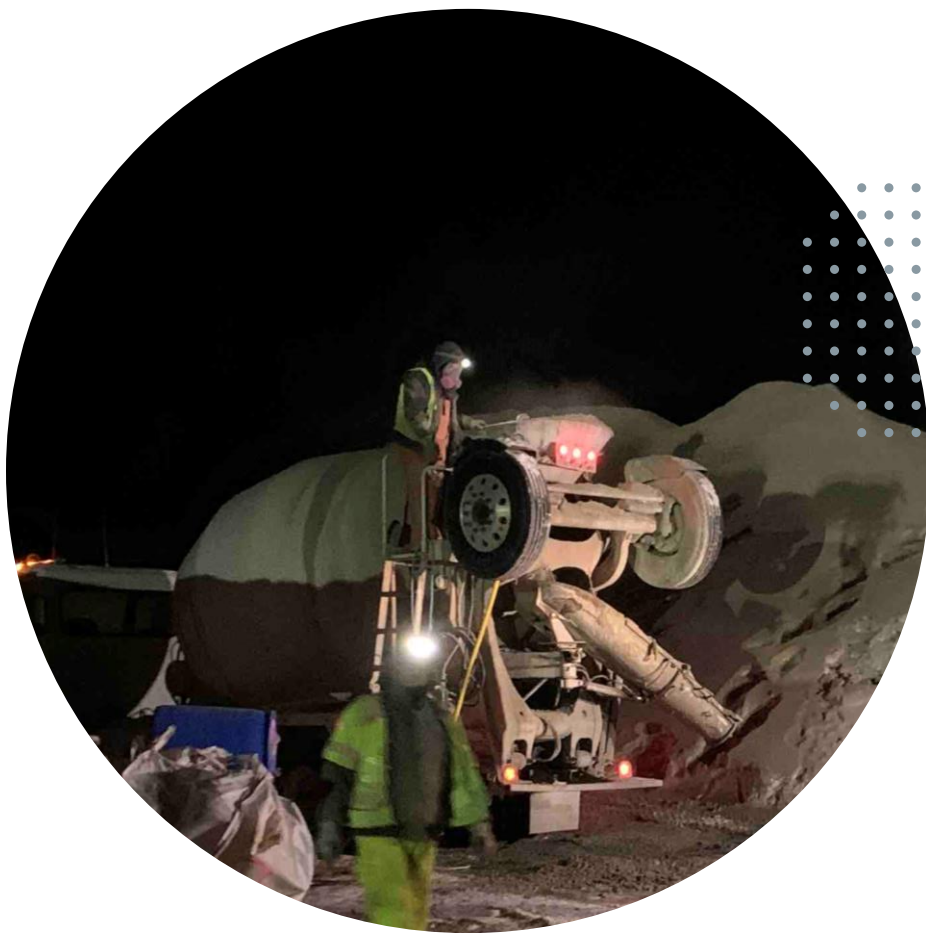
Concrete Temperature Sensors

- Temperature sensors cast in concrete
- Data to mobile device via Bluetooth
- Temperature differentials in mass concrete
- Max/min curing temps in harsh setting
- Maturity method strength monitoring

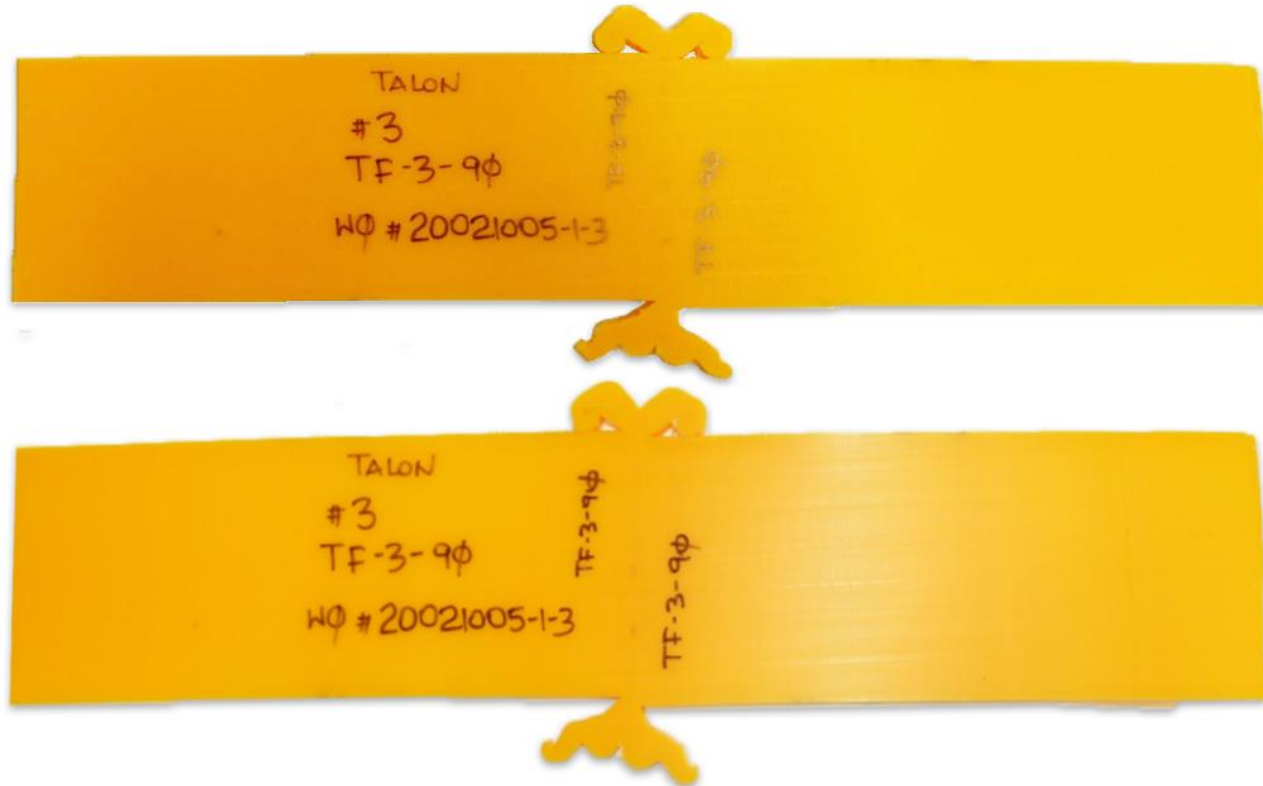
Pre-Production Destructive Joint Tests

- Pre-production destructive joint tests
- Pre-weld cleaning and inspection
- Fusion machine joint report
- Post fusion offset check

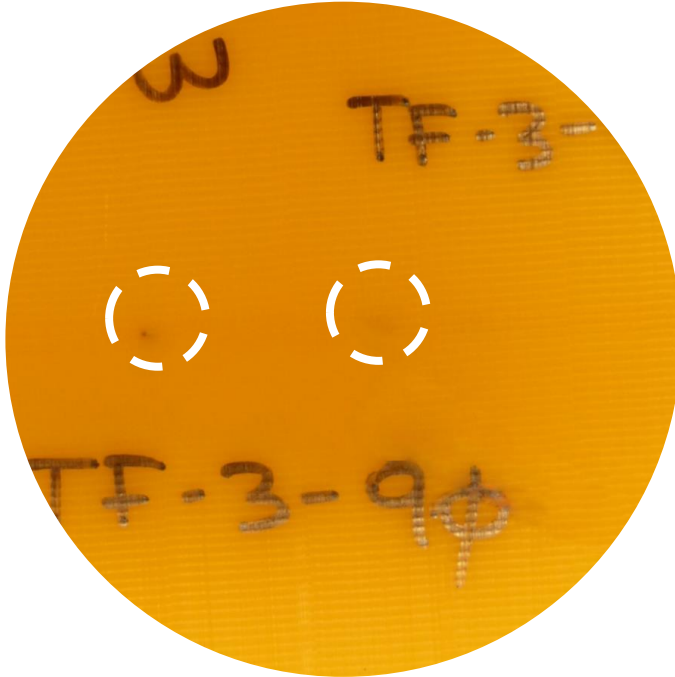
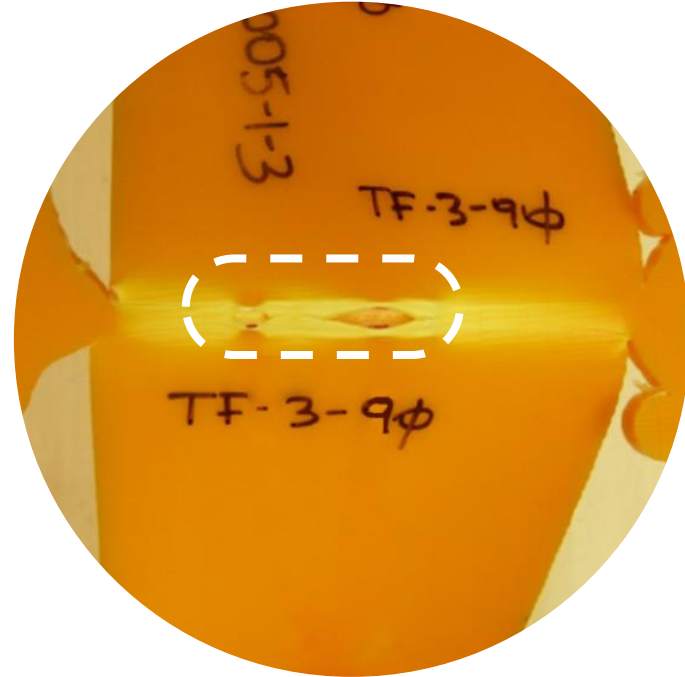
Destructive Joint Tests

Locations of contamination in fusion bead

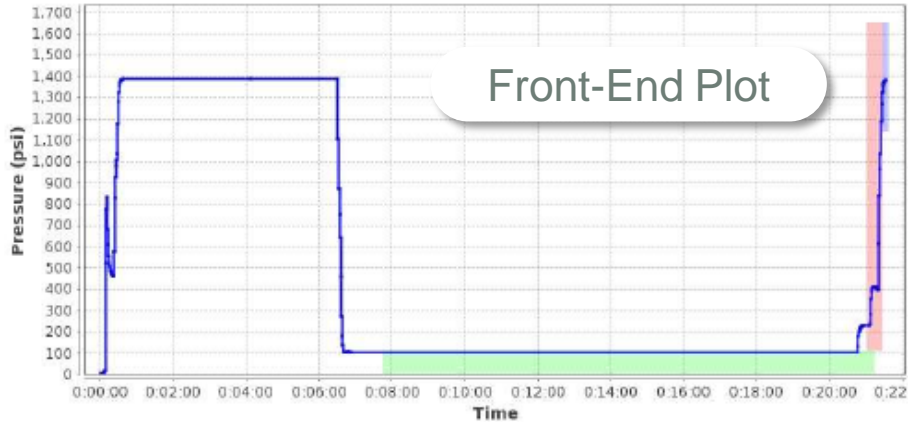
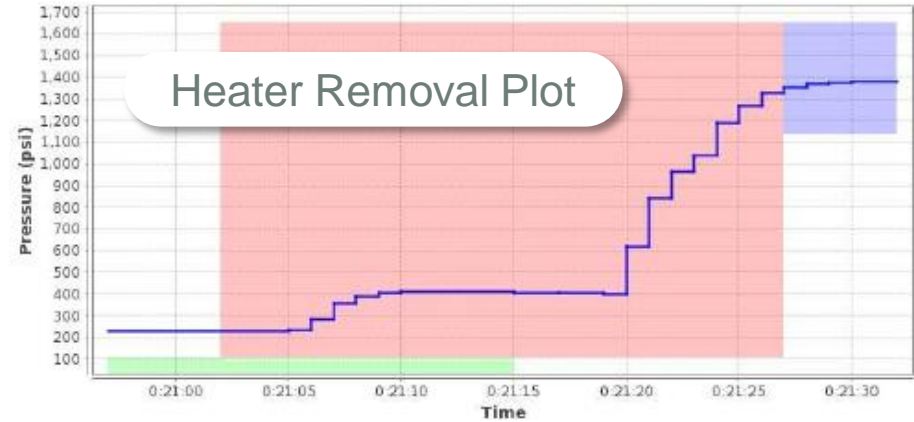
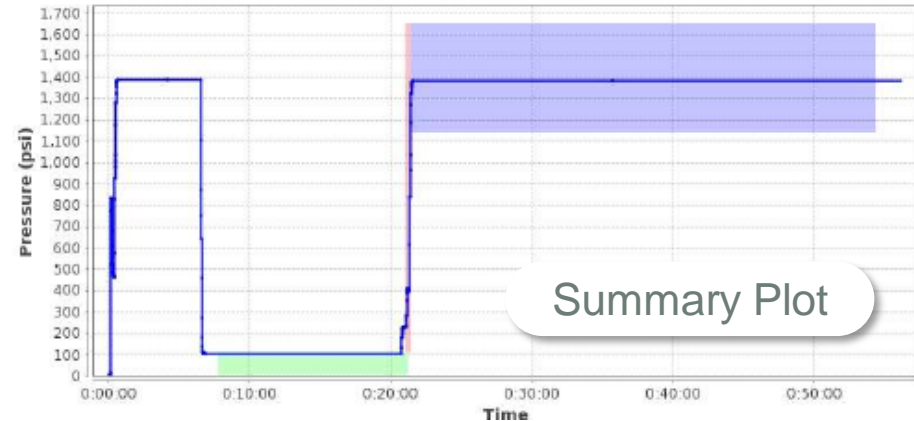
Fusion Machine Joint Report

Source: McElroy Joint Report

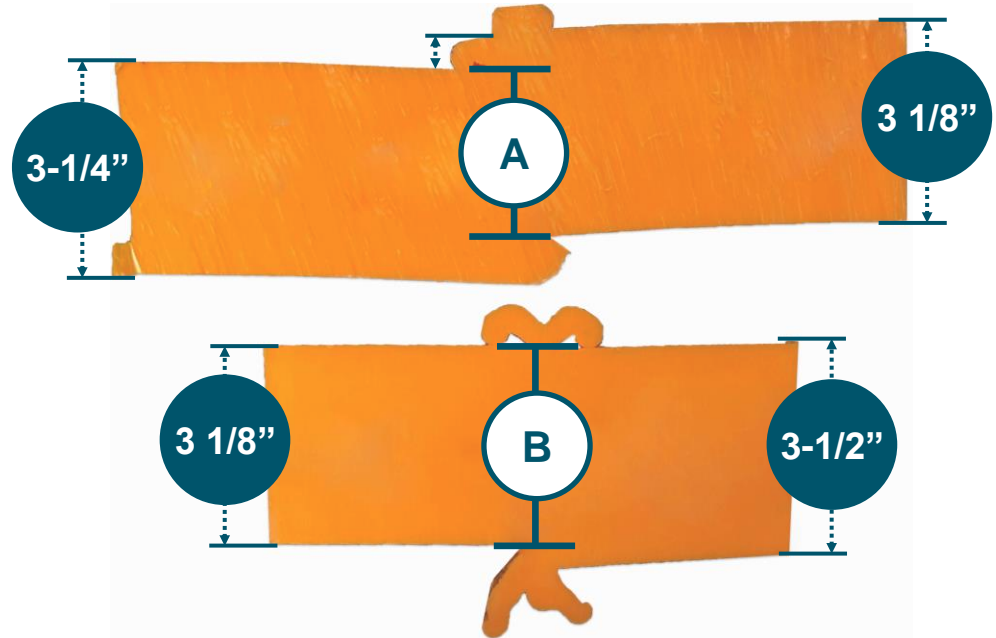
HDPE Offset Check

- Low-tech method – jig and caliper measurement inside and outside pipe
- Remove/replace when fails

Fusion Length	Joint Offset
A	2 5/8"	~3/4"
B	3 1/8"	~1/4"
